Manhole Inspection Summary

Manhole # S23M1_002MH

Location Address: **3025 MALLVIEW DR**

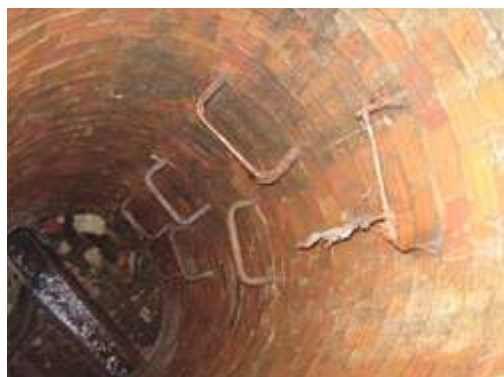
Defect 6

☒ **Evidence Of Surcharge** Depth: **8** (ft.) ☐ Active Surcharge Present

Evidence of surcharge

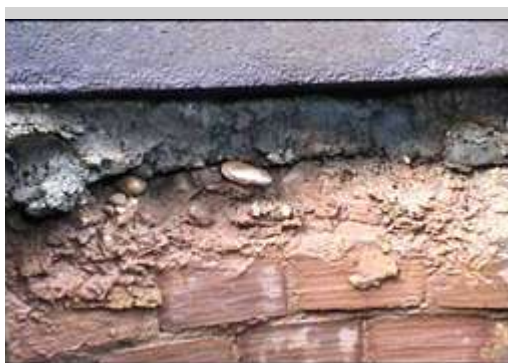
Defect 5

Condition: ☐ Sound ☒ **Cracked** ☐ Root Intrusion ☐ Loose Brick ☒ **Deteriorated**

Infiltration: ☐ None ☒ **Joint** ☐ Cracks ☒ **Mortar** ☐ Roots ☐ Wall

CHIMNEY/FRAME JOINT INFILTRATION
MISSING MORTAR & deterioraton

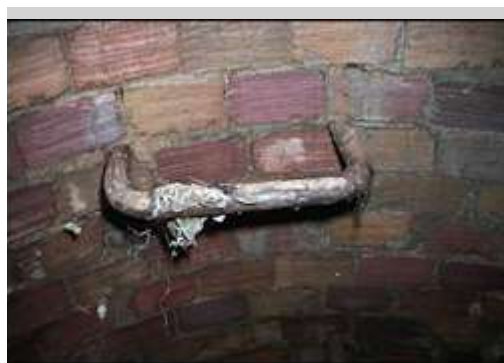
Defect 4

Count: **7** Missing: **0** ☒ **Corroded**

CORRODED RUNG

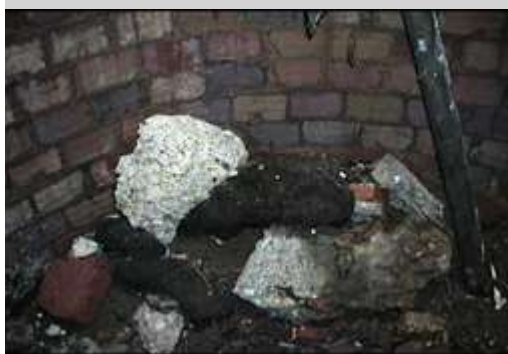
Defect 1

Condition: ☐ Sound ☐ Cracked ☐ Root Intrusion ☐ Deteriorated ☐ Leaks ☒ **Debris**

DEBRIS ON BENCH
